# All Phase Home Inspection, Inc.

## **Confidential Home Inspection Report**

Of  
Mr. and Mrs. Smith  
123 Apple Lane  
Long Island, NY  
Friday, September 14, 2007

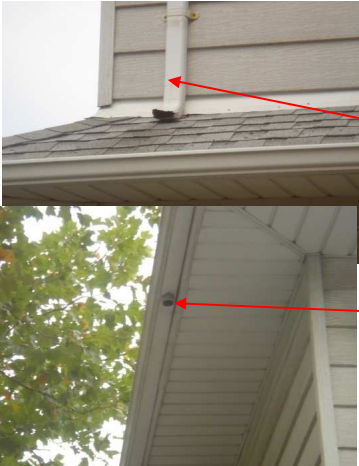
Down spout should have an extension to defer water directly to the gutter.

Downspout should be added to direct water to the gutter, not empty onto the roof.

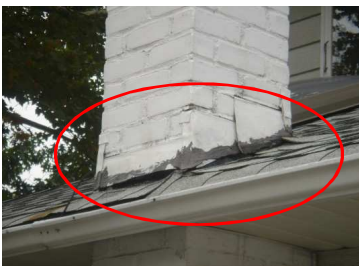
Flashing around chimney needs immediate attention.

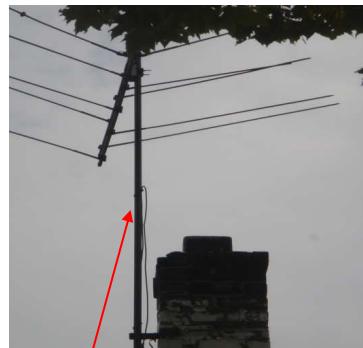
Unused antenna should be removed, to decrease resistance on chimney.

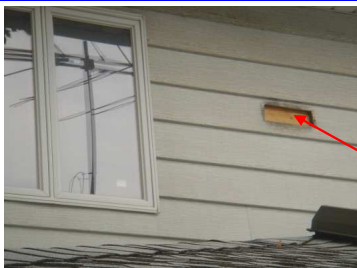
Missing siding,  
needs to be covered  
to prevent water  
intrusion.

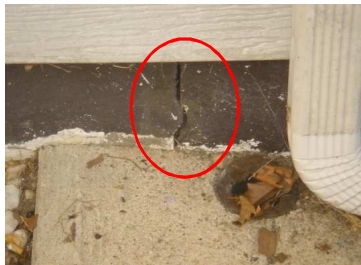
Crack goes through to the interior of the garage. Repair by a licensed professional.

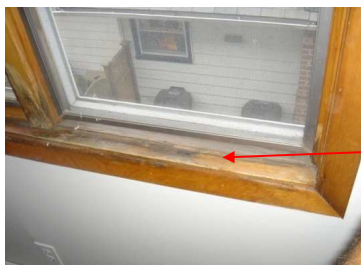
Missing molding and water damaged sill.

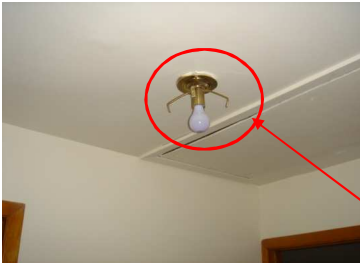
Damaged lighting fixture.

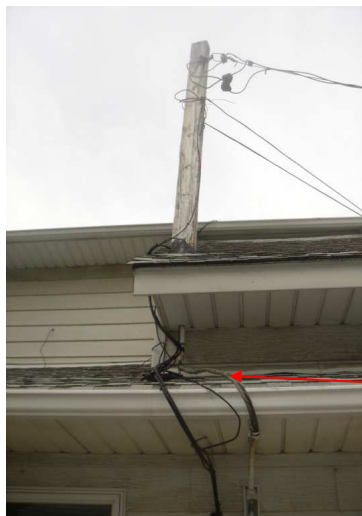
Insulation is peeling off the service entrance. The service entrance is run over a gutter.
